**Characterization of decay in the wooden roof
of the S. Agata church of Ragusa Ibla (southeastern Sicily)
by means of sonic tomography and Resistograph[®] penetration tests**

Abstract We describe the results of a sonic tomography survey and penetration tests carried out inside the S. Agata church of Ragusa Ibla, in southeastern Sicily (Italy). The purpose of this work was to evaluate the extent of decay in some of the ancient wooden trusses of the nave's roof, in view of possible strengthening interventions. Sonic tomography is entirely non-invasive and is suitable to investigate large portions of a structure, although in a qualitative way, while penetration tests are little invasive, point measurements that enable high-resolution detection of wood decay and cracks. We combined the two techniques to investigate the internal condition of 4 trusses that looked most deteriorated at a preliminary visual inspection. Results showed that decays mainly occur in portions of the timbers that are next to the walls, due to rainwater infiltration, and on the side facing the rear end of the nave; in general, chords have worse mechanical properties than rafters.

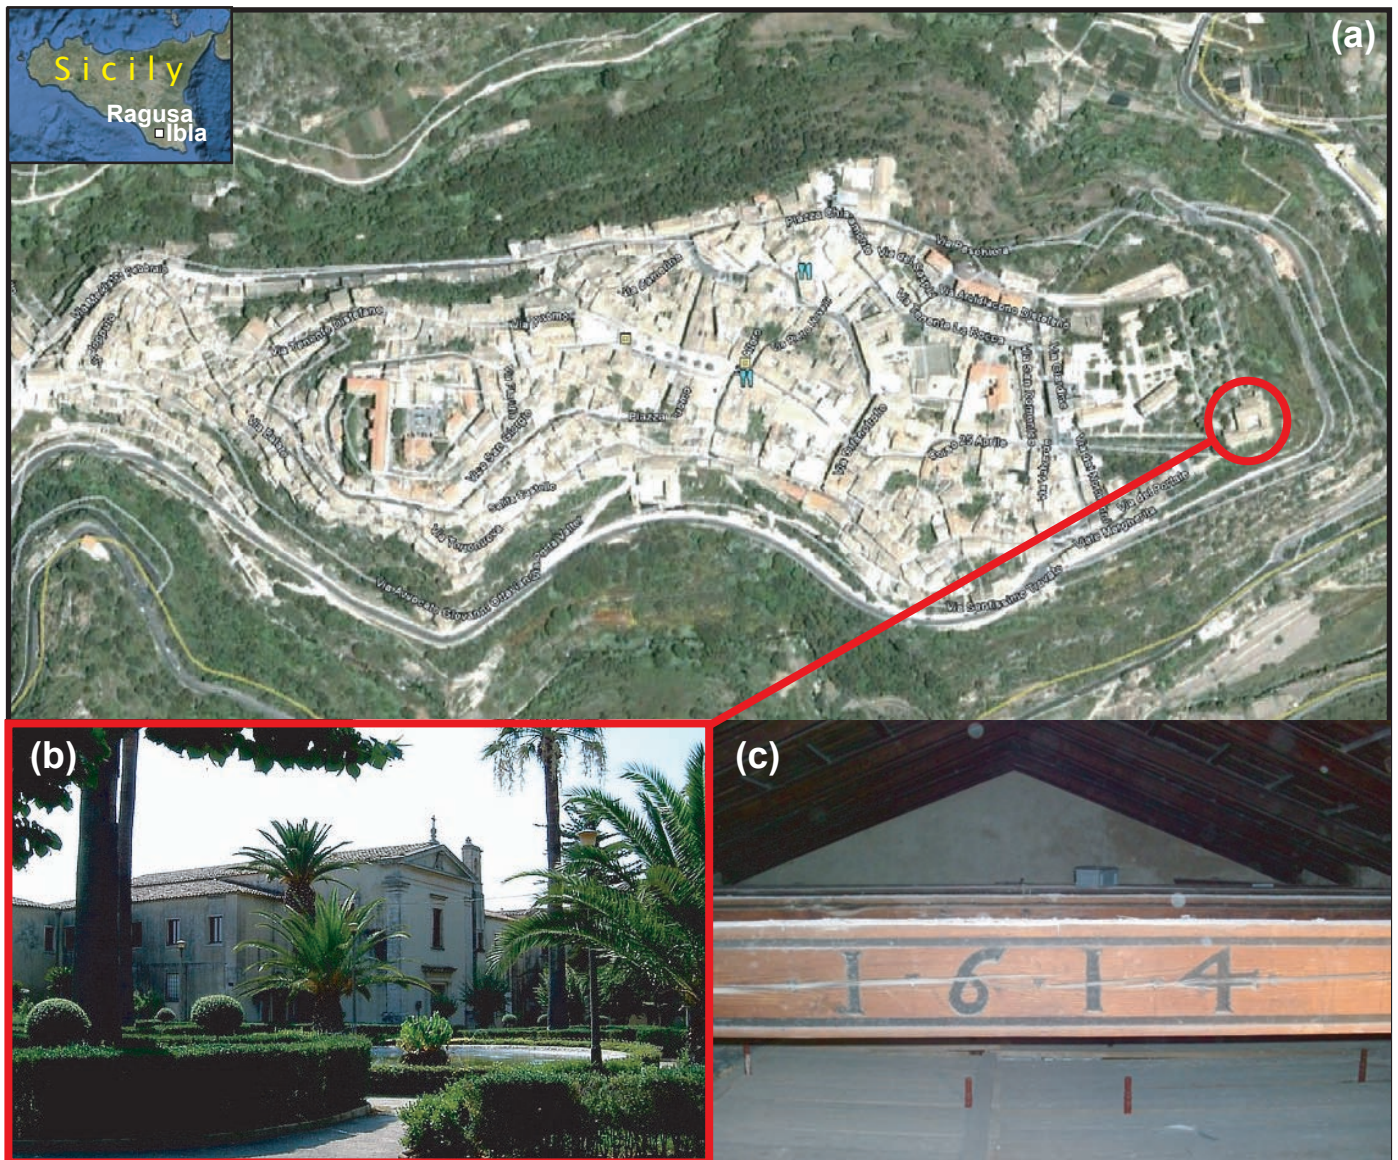
Figure 1 (a) Aerial view of the historical village of Ragusa Ibla and (b) location of the S. Agata church; (c) the date 1614 is carved into one of the roof trusses, probably referring to its construction.

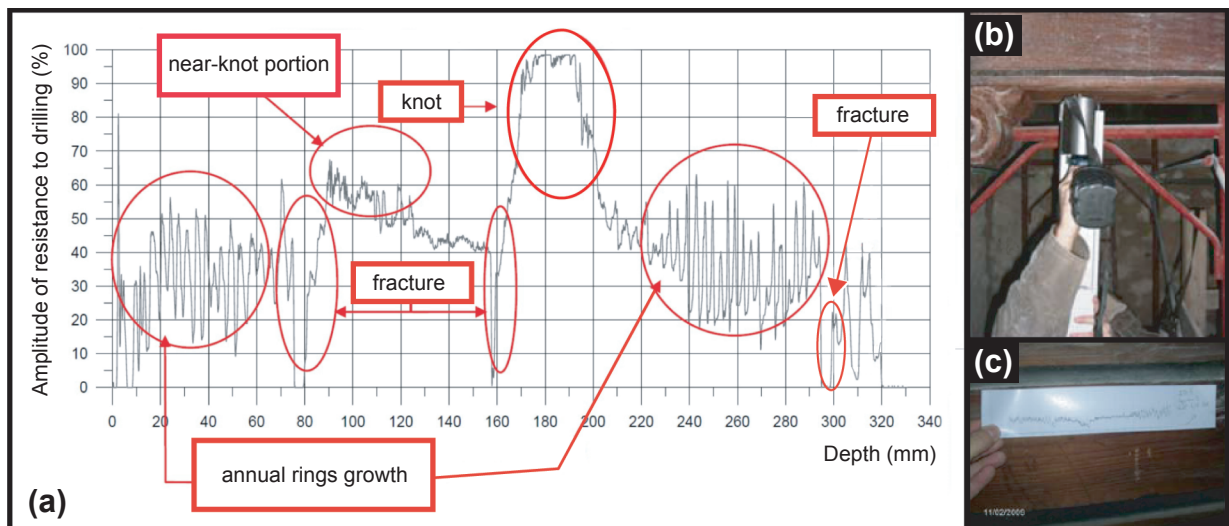
progressively reached by the tip. A resistogram illustrates the natural heterogeneity of wood and the presence of decay and fractures, as in the example of Figure 3a. It is dominated by series of positive and negative peaks due to the annual rings growth - minimum peaks corresponding to early wood portions formed during springtime, maximum peaks corresponding to late wood rings formed during fall. Decayed wood has a lower resistance to drilling with respect to sound wood; in case of fractures or voids, as well as total decay, the resistance profile goes to zero. Knots corresponds to the highest resistance amplitude.

In the present work, we have performed 15 tests, 12 on chords and 3 on rafters, using the Resistograph[®] IML-RESI F400 system with a needle of 3 mm in diameter (Figure 3b). Drilling depth ranges between 16 and 24 cm depending on the thickness of the timber in the drilling direction, horizontal or vertical. With this instrument, data are recorded digitally on a computer and printed in real time on a wax paper strip at 1:1 scale (Figure 3c), to allow a direct comparison with the structure under test. In the digital recordings, quality assessment is automatically provided, as data are displayed, with a sequence of colored bars distinguishing portions of wood characterized by similar response to drilling.

Figure 3 (a) Example profile of resistance to drilling and interpretation of the density behavior; (b) use of the penetration test equipment; (c) printout of a resistogram obtained in this survey.
